NACA TN 3190

TECHNICAL NOTE 3190

FATIGUE INVESTIGATION OF FULL-SCALE  
TRANSPORT-AIRPLANE WINGS

SUMMARY OF CONSTANT-AMPLITUDE TESTS THROUGH 1953

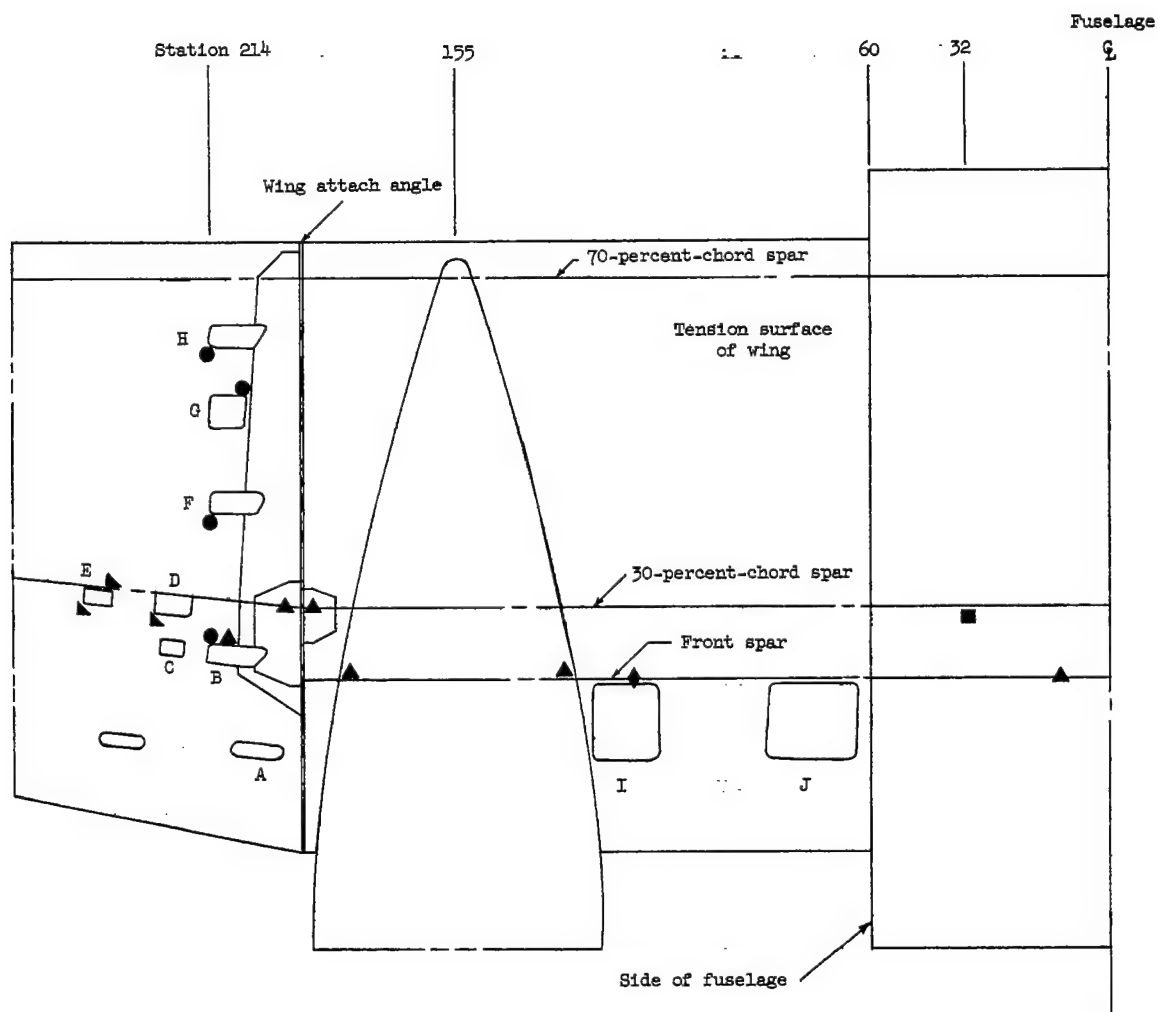
Figure 5.- Locations and types of fatigue failures.

The five types and their locations are shown in the plan view of the tension surface in figure 5, and are illustrated in figures 6 and 7. Most of these types of failures occurred in stress raisers which would be present in similar form on almost any metal aircraft structure.

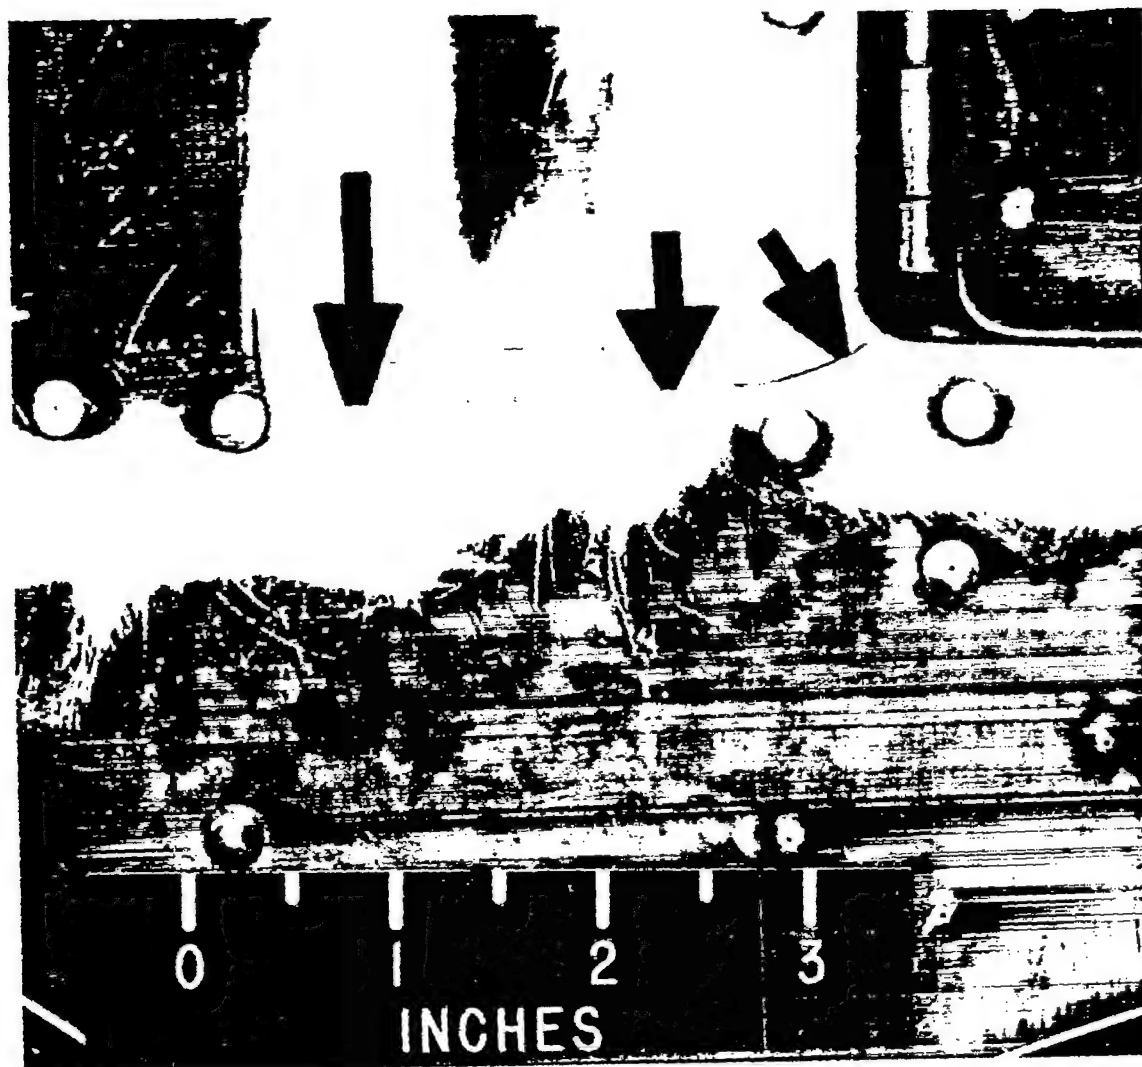
L-77922.4

The type I failures originated in the corners of inspection cutouts B, F, G, and H, and examples are shown in figures 6(a) and 6(b). These cutouts had non-load-carrying covers and were all at span station 214. Most of the failures occurred in the vicinity of the spar at the 30-percent-chord position, which was the most highly stressed region as indicated by the chordwise stress-distribution survey at this station. Since span station 214 contained numerous cutouts, doublers, and other discontinuities and therefore yielded an irregular stress distribution, another chordwise survey was made at span station 235, which was the nearest station that was free of these discontinuities. The gages used in these surveys were oriented so as to measure the strain in a spanwise direction. The results of these surveys are presented in figure 8, along with a cross section of the tension surface at span station 214. This figure indicates that for both of these stations the highest stress occurs in the vicinity of the 30-percent spar.

(a) Type I failure at forward outboard corner of inspection cutout F.

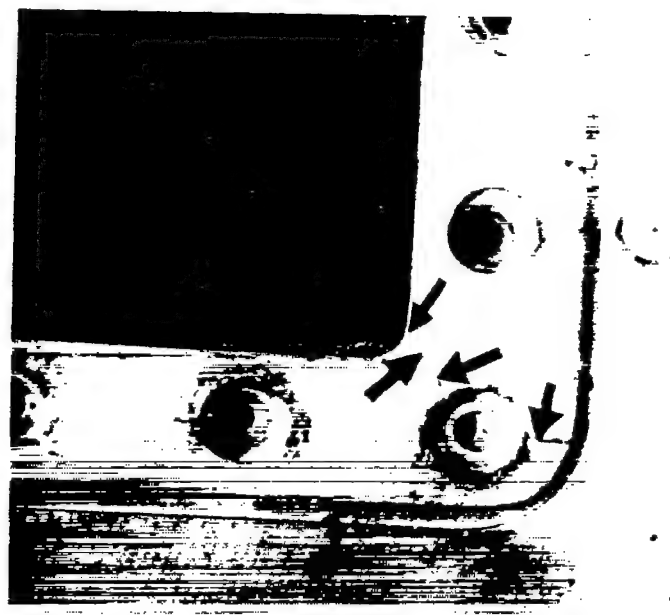
The type IV failures occurred in internal reinforcing doubler plates around cutouts D and E, located outboard of span station 214 and immediately forward of the 30-percent spar. A photograph of this type of failure is presented as figure 6(d). These cutouts had cover plates that were fastened to the reinforcing doubler plate with machine screws and channel nuts. The failures originated in the screw holes on some wings and in the smaller-radius corner of the internal doubler plate on others, frequently occurring very early in a test. These failures spread into the skin on only two occasions but in no case did they grow to more than a few inches in length.

(d) Type IV failure in reinforcing doubler plate at inspection cutout D. L-77924

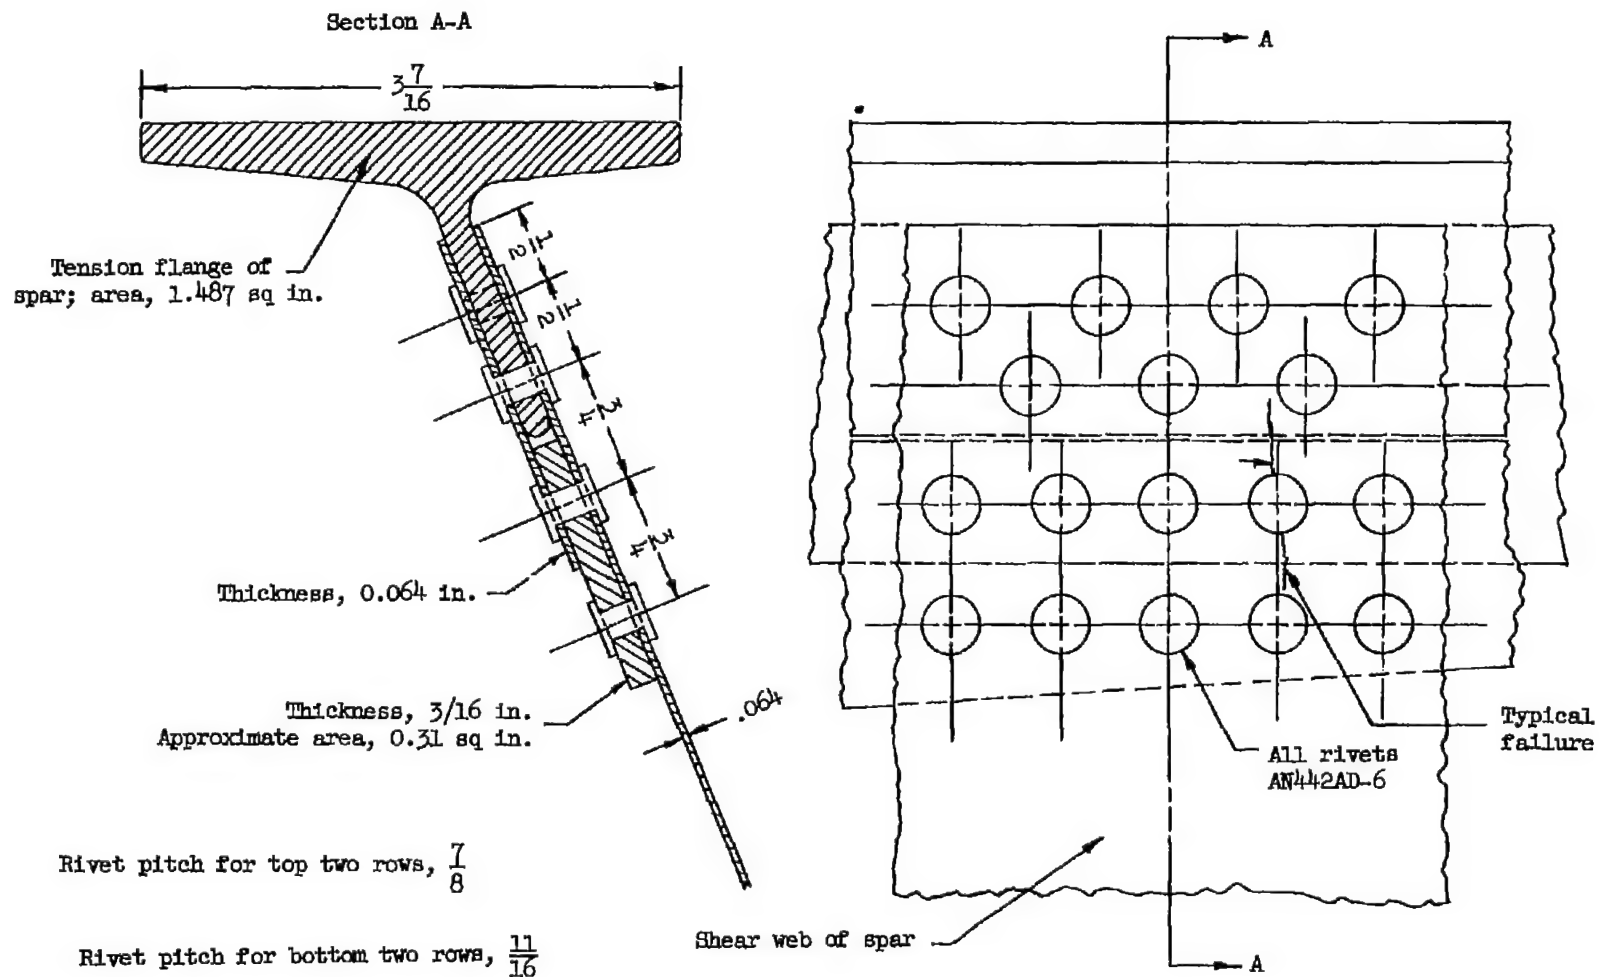
Figure 7.- Details of riveted shear joint at span station 120 in which type III failures occurred.

The type III failures occurred at span station 120 in the riveted joint connecting the shear web to the tension flange of the front spar. Since this location was very difficult to photograph, a drawing of the details of this joint is shown in figure 7. The cracks usually progressed vertically through the shear web and were accompanied by a crack in a small piece of skin over the spar cap.
